Your Inspection Report

123 AnyTown St
New York NY 12345

Prepared for: *Mr. Smith*

Prepared by: *Home Inspection Services, LTD*
32 Long Meadow Dr
New City, 10956
Your Home, Your Dream,
We Make It Come True

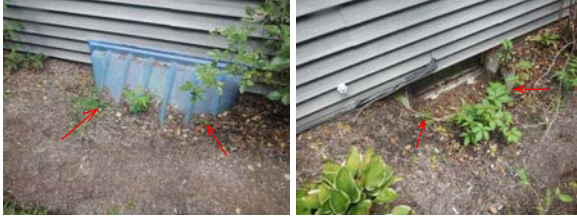
9. Marginal

Window Wells: See Notes: Excessive mulch was added and is now higher than the basement window well. This will direct water in a heavy rain into the well which may direct water into the basement. We recommend removing as much mulch as possible and adding a window well cover.

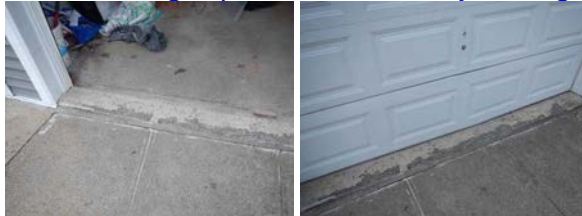
4. Marginal

Driveway: Insulated aluminum - **Driveway has settled near the garage opening. This has caused a large lip to form. This may damage the tires. Additional material may be required.**

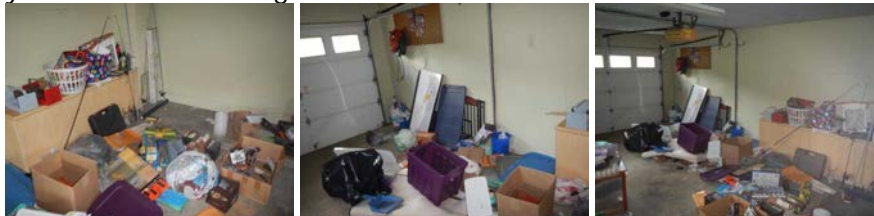
12. Acceptable

Walls: Sheetrock - The majority of the wall surfaces were blocked by storage and could not be evaluated. Only visible areas are reported on. We recommend rechecking his area during your final walk through.

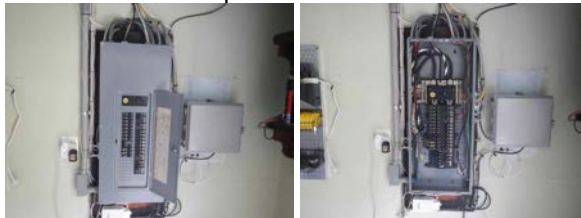
15. Suggested Items Panel Cover Attachment: Missing Cover Screws - Missing panel cover screws should be replaced to contain electrical fire as well as properly securing panel cover.

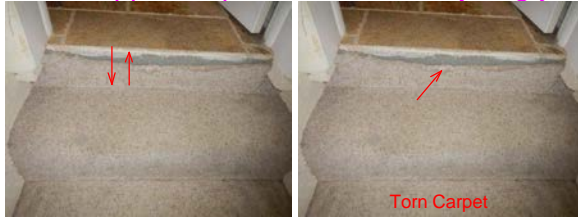
18. Suggested Items Basement Stairs/Railings: Carpet Covered - 1. Improper riser height may pose a trip hazard and care should be used.

2. The upper carpet is torn and may nag your feet. Recommend removal.

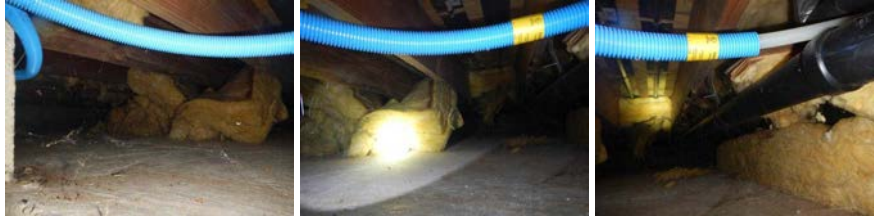
8. Marginal

Insulation: Fiberglass - [Some insulation has fallen out of place and should be reinstalled for energy efficiency.](#)

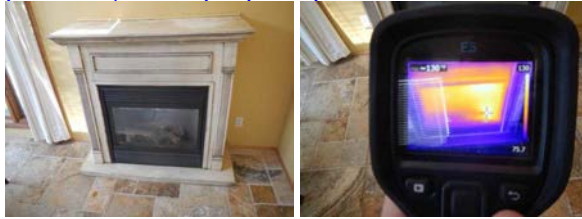
1. Marginal

Fireplace Construction: Built In - [Could not be operated when tested. Consult with owner \(if possible\) as to proper operation or have evaluated by a chimney company.](#)

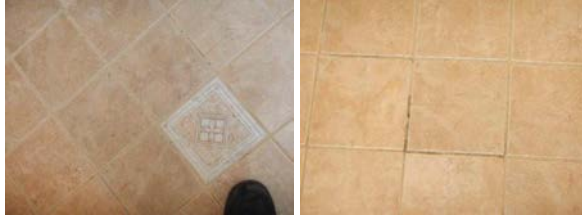
Floor: Ceramic tile - **1. Cracked floor tiles noted and should be repaired where needed. Care should be taken due to the sharp edges that may be present that could cause harm to someone stepping on the tile. Consult with a licensed contractor and repair where required.**

2. Loose tile/grout, repair as required.

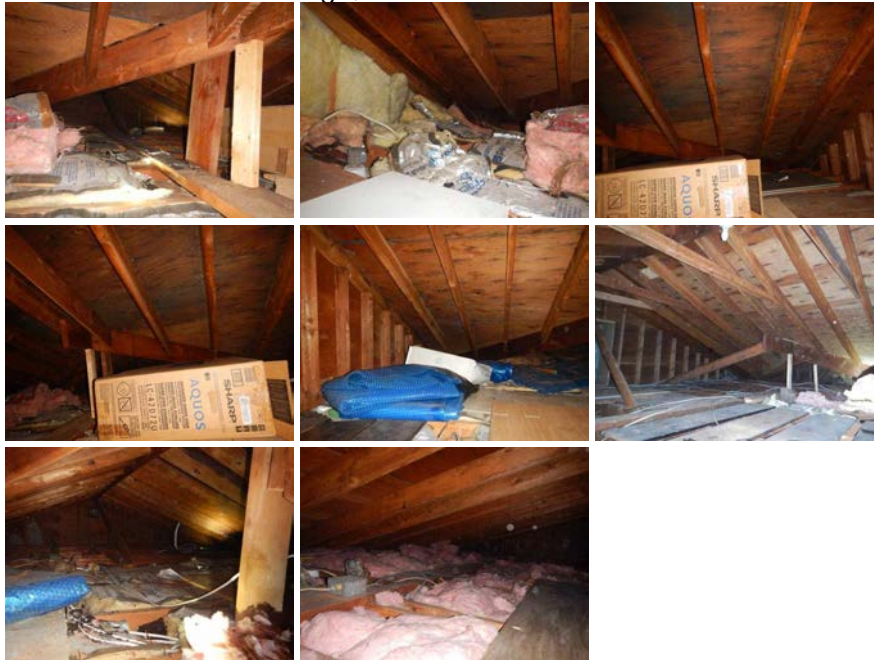
3. Acceptable Unable to Inspect: See Notes: Due to low ceiling height some areas of the attic could not be accessed and comments are made from these access points.

Due to insulation coverage, all areas of the substructure could not be reported on.
